Geohydrological Assessment for Cape Lime -Vredendal Dolomite and Limestone Operations.

GEOSS Report No: 2019/09-04

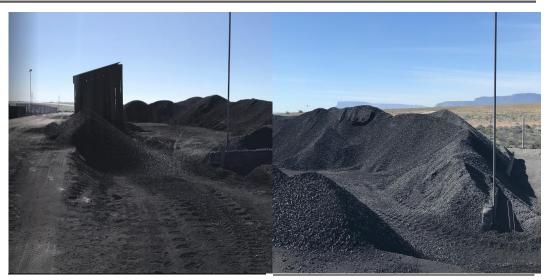
Photo 7: Coal stockpile (overflow)

Photo 8: Coal stockpile (overflow)
