Appendix 7:
Geohydrological Specialist Report

*Geohydrological assessment of a proposed
sand mine, Portion 2 of the Woodlands farm
874, Malmesbury*

GEOSS Report No: 2015/03-11

24 March 2015

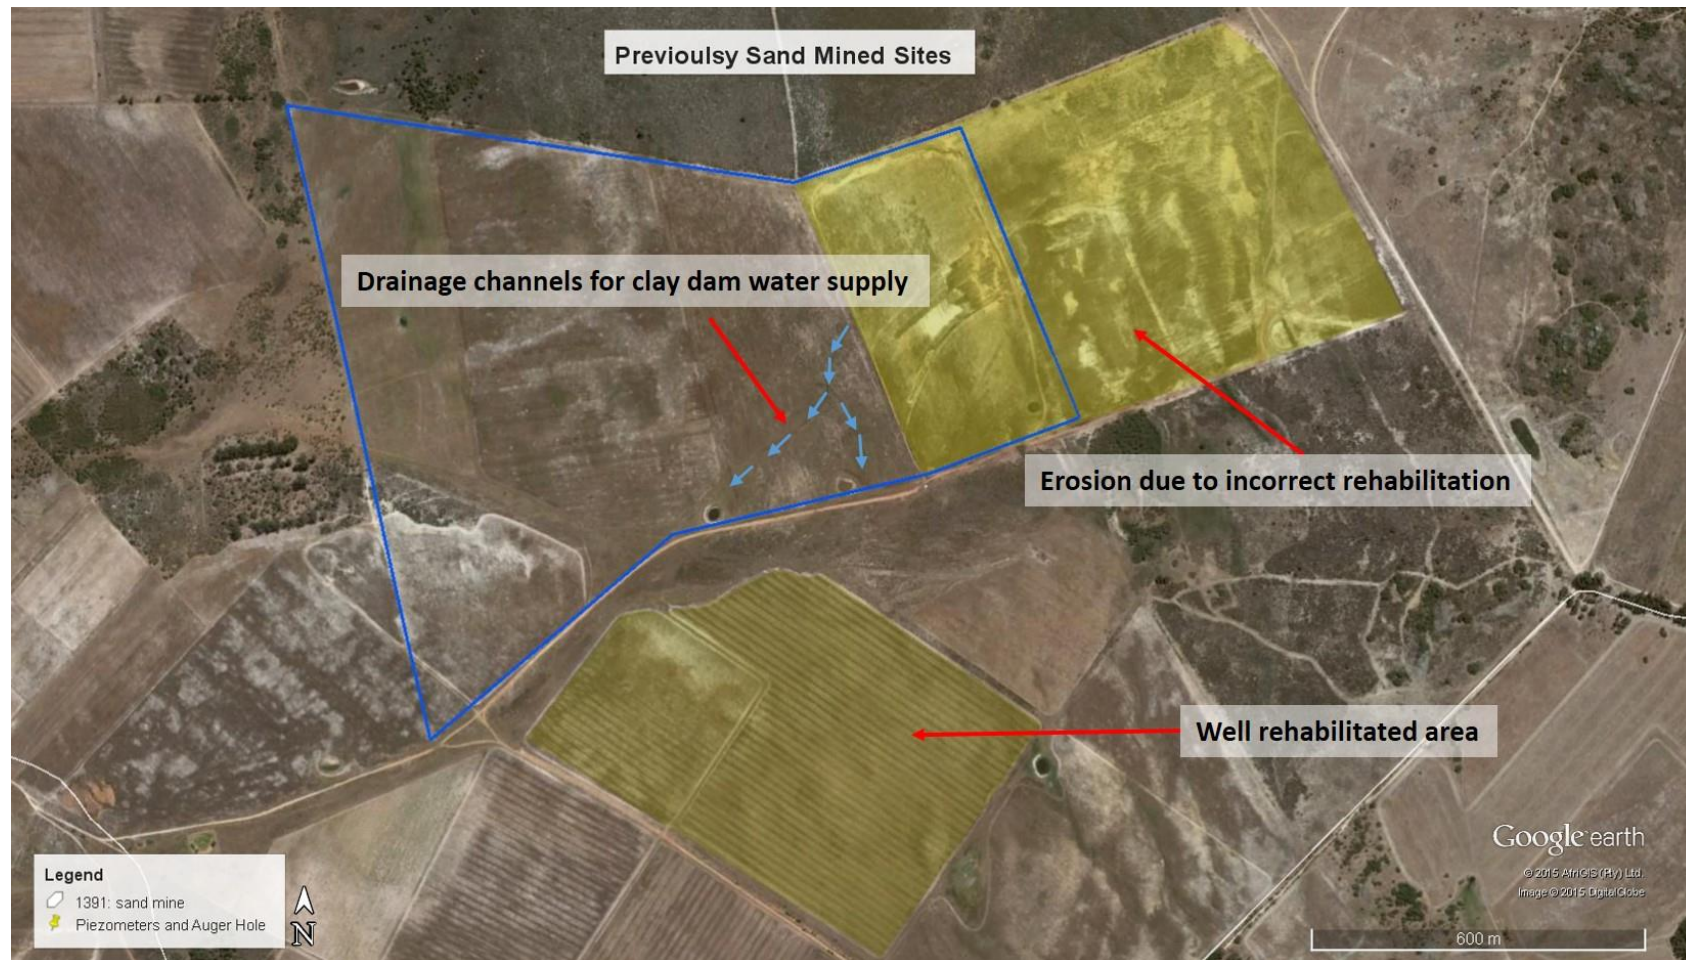
Map 7: Previously sand mined areas

- According to the land owner sand mining has previously taken place adjacent to the site (**Map 7**). To the south of the site, the land was correctly rehabilitated with topsoil and as a result erosion is negligible. However to the east of the site rehabilitation was not completed and erosion is easily evident (photos in **Appendix C**).

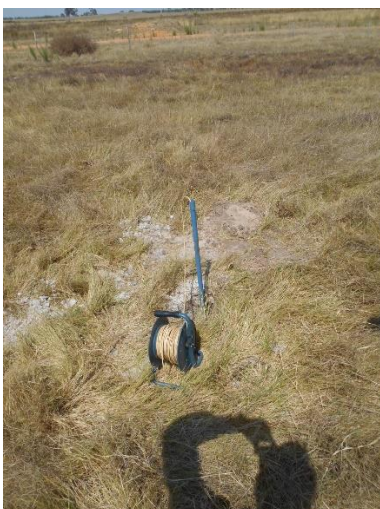
Piezometer Site 01 (PZ_1)

Date	Time	Site_ID	Lat_WGS84	Long_WGS84	Elevation (mamsl)
12/3/2015	10:15	PZ1	-33.60431	18.75613	171
Depth (m)		Description			
From	To				
0	0.2	Dry, brown-grey, loose, silty sand, with roots and root holes.			
0.2	1.1	Very dry, light grey, very loose sand with quartz grains approx. 2 mm in diameter.			
1.1	1.29	Dry, brown white shards of sandy clay, with mottled red and purple brown clay and sand.			
1.29	1.6	Dry, light grey to white, very loose sand with angular quartz grains of up to 2 mm diameter.			
1.6	2.2	Slightly moist, light grey sandy clay, with speckled red and mottled blk sandy clay lenses, as well as root			
2.2	2.73	Moist, light grey, firm clayey sand, with blotches of dark brown and black sandy clay.			
2.73	3.5	Very moist, light grey, clayey sand, with speckled black and red clay snd lenses.			
3.5	4.01	Wet, grey, clayey sand.

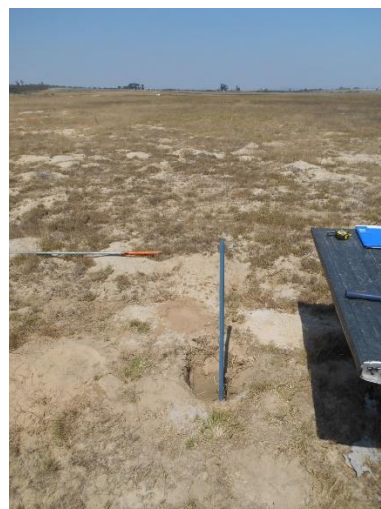
Piezometer Site 02 (PZ_2)

Date	Time	Site_ID	Lat_WGS84	Long_WGS84	Elevation (mamsl)
12/3/2015	12:58	PZ2	-33.59975	18.75376	172
Depth (m)		Description			
From	To				
0	0.2	Vey dry, brown grey, loose silty sand with roots and organic material.			
0.2	1.1	Dry, brown grey, very loose, silty sand.			
1.1	2.2	Slightly moist, light brown, loose silty sand.			
2.2	Collapse	Moist, light brown, loose silty sand.			
Note: Hole continuously collapsing at this depth due to loose sand in water table

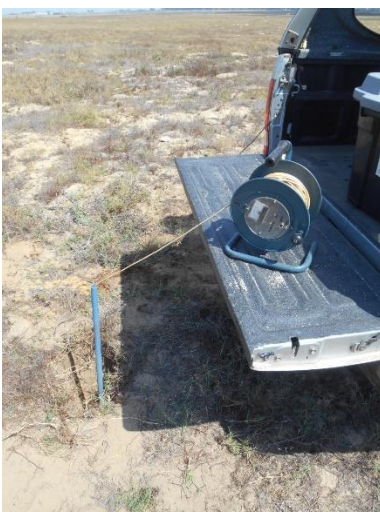
Piezometer Site 03 (PZ_3)

Date	Time	Site_ID	Lat_WGS84	Long_WGS84	Elevation (mamsl)
12/3/2015	14:05	PZ3	-33.59925	18.75095	166
Depth (m)		Description			
From	To				
0	0.3	Dry, loose, grey brown, silty sand, with roots and organic material.			
0.3	0.5	Dry, loose, grey brown, dense, silty sand.			
0.5	0.8	Slightly moist, red brown, loose silty sand.			
0.8	1.54	Moist, loose, dark brown, silty sand			
1.54	2.1	Very wet, dark brown silty sand.			
2.1	2.4	Wet, brown white, silty sand with lenses of black and yellow silty sand.

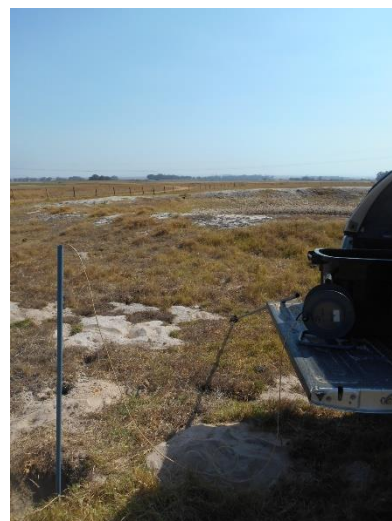
Piezometer Site 04 (PZ_4)

Date	Time	Site_ID	Lat_WGS84	Long_WGS84	Elevation (mamsl)
12/3/2015	15:30		-33.6049	18.75283	162
Depth (m)		Description			
From	To				
0	0.4	Dry, grey brown, loose, silty sand, with roots and organic material.			
0.4	1.14	Dry, grey brown, loose, silty sand.			
1.14	1.92	Slightly moist, grey brown, clayey sand, with mottled red clayey sand.			
1.92	3.2	Moist, grey brown, clayey sand, with mottled red clayey sand.			
3.2	4.1	Wet, grey brown, loose silty clay sand with mottled red and white clayey sand.			
4.1	Collapse	Very wet, grey brown silty clay sand. Hole continuously collapsed at this depth.

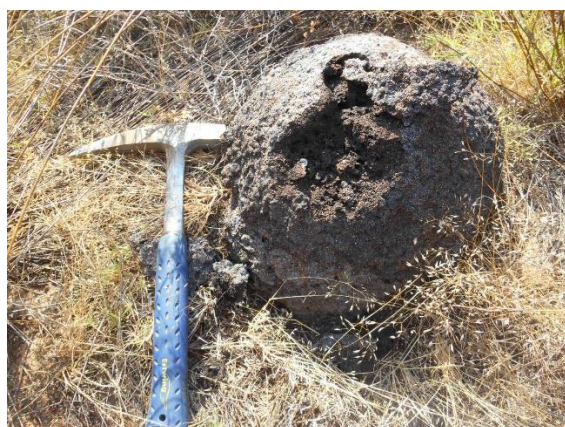
- The auger hole in the drainage region was hand drilled to a depth of 2.3 m. No water table was intersected and very little clay was present.
- Termite mounds were found throughout the drainage area which correlates with a deeper groundwater table (photos in **Appendix C**)

Termite mound, occurring commonly in drainage area

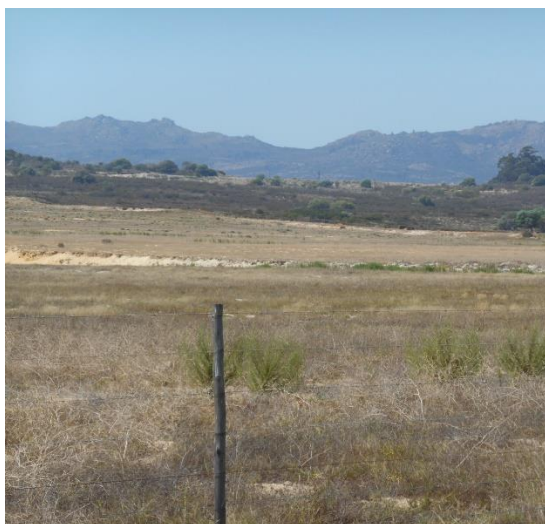
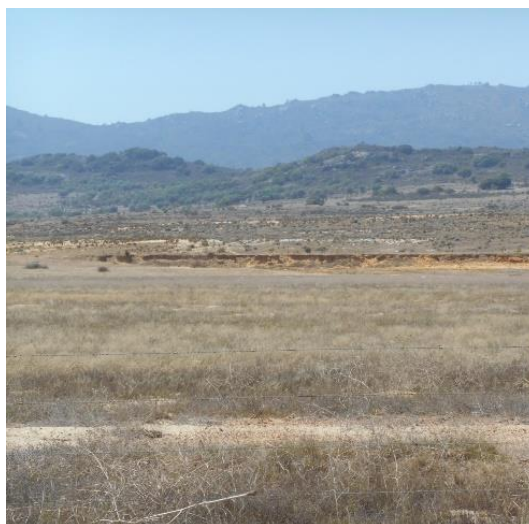
Erosio on the eastern boundary of site

Erosion on eastern boundry of site

- The sand mining must not go deeper than the consolidated silt / clay layer.
- The mining must not take place during or just before the rainfall season.
- The strips of soil that are removed should be done so at right angles to the slope, as this will slow down surface runoff and help to prevent erosion.
- Rehabilitation by replacing topsoil on the stripped land should take place before the next strip is opened and mined.
- All machinery must be in excellent condition and there must be NO oil/fuel leaks whatsoever from equipment.
- If a spill does occur, it must be immediately reported to the relevant authorities and immediately remediated.
- A short report (with photographs) should be completed prior to and on completion of the mining to the relevant authorities by an Environmental Control Officer (ECO).

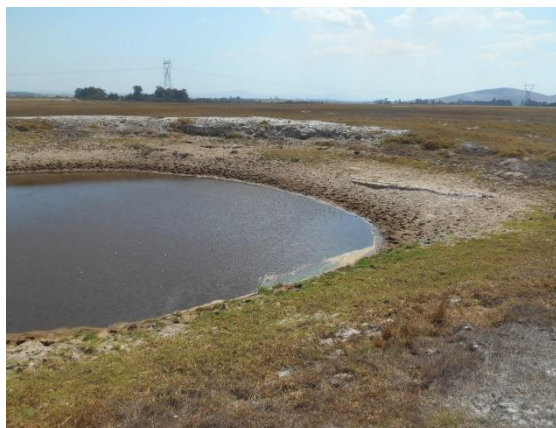
- During the site visit there was water present in the abovementioned dams, albeit at a very low level (photos in **Appendix C**).
- The groundwater level measured in the northern part of the site (PZ3) was shallower than that of the southern piezometers (PZ1 and PZ4), whilst no groundwater table was intersected in the auger hole in the drainage area (AH_5). This suggests that the groundwater table depth dips towards the south of the site and correlates with the land owners point that flow of the drainage area only occurs after/during heavy rainfall events.

Clay dam on site
