BIODIVERSITY ASSESSMENT: WOLVE KOP MINE, NEAR MIDDELBURG, EASTERN CAPE

June 2021

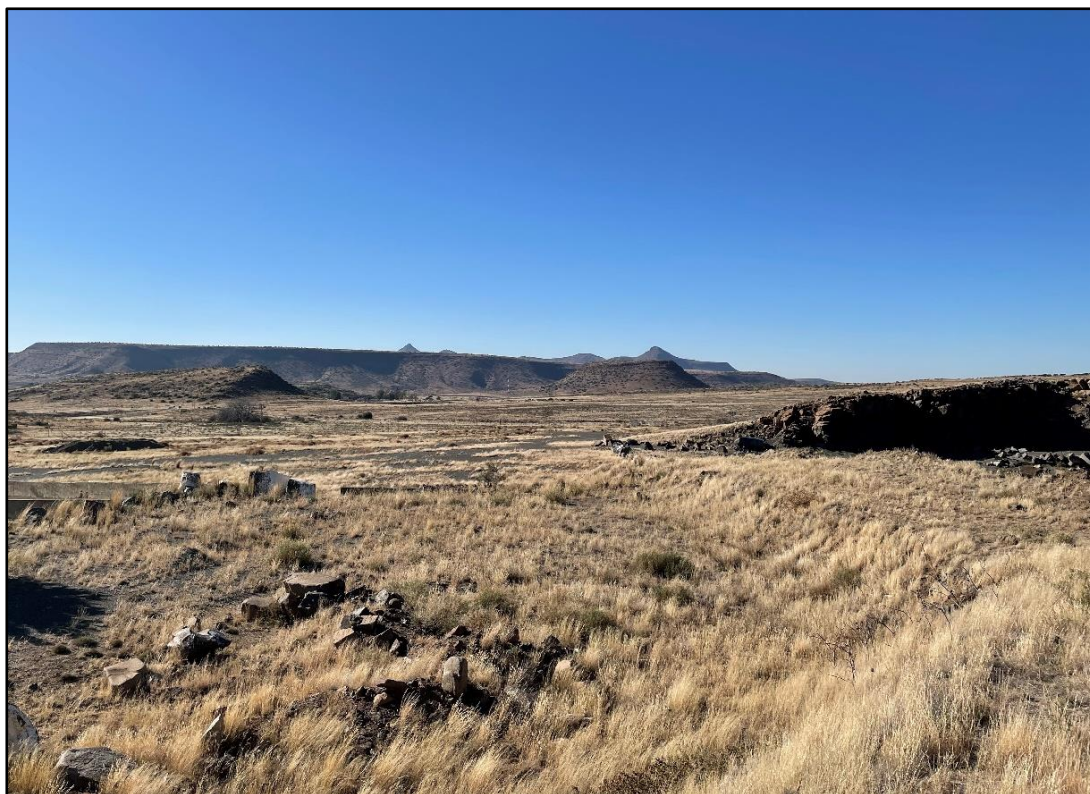
Photo 1 View of mining site showing the general topography of the area.

The site (5 ha) is located on an east-facing hillslope in the Eastern Cape upper Karoo, a high-lying area above the Escarpment. The general topography is undulating or hilly (see Photo 1). Apart from the rocky hills there are no other significant topographical features. The landscape to the northeast flattens out a bit before it rises up again to the hills on the eastern side of the small valley. The topography seems to be largely influenced by resistance to weathering of the base rocks (dolerite and sandstone).

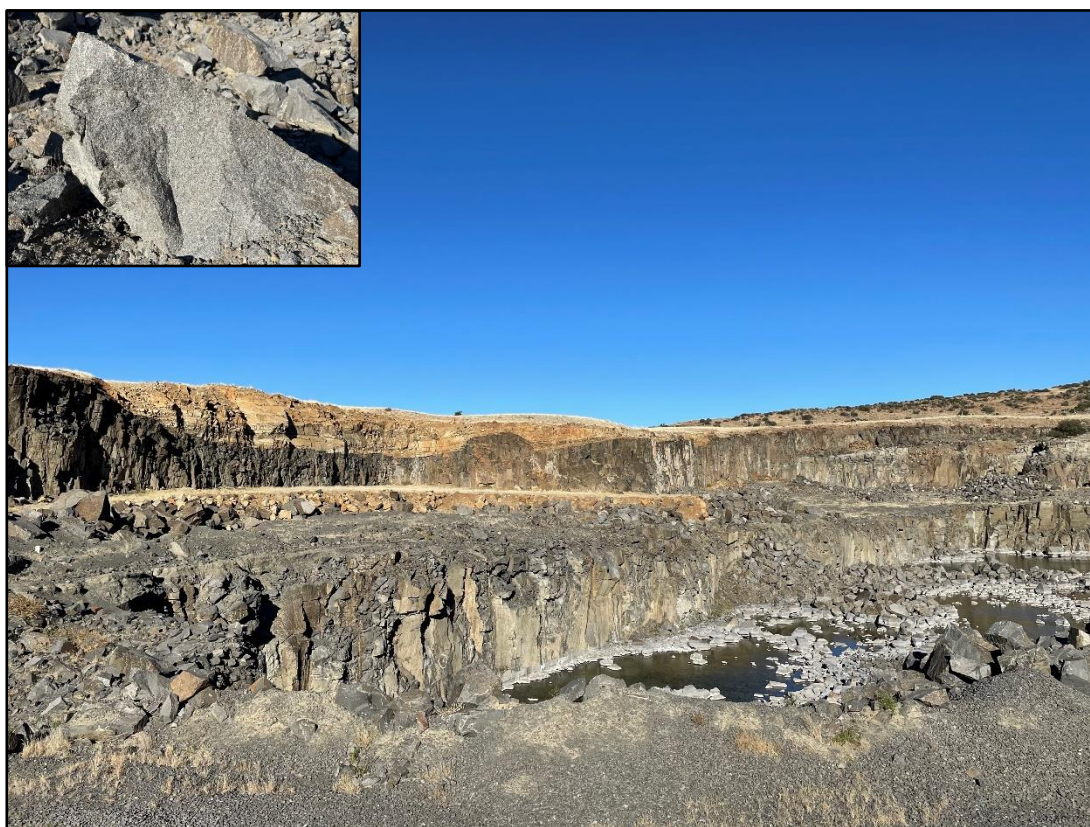
Photo 1 View of quarry. Insert: dolerite rubble near entrance

comprising dolerite and minor ultrabasic rocks. The former is the source of mining activities on site (see Photo 1 above). Tarkastad Formation (upper Beaufort Group) sediments (fine- to medium-grained sandstones and mudstones) were also noted outside the site to the northeast (see Photo 2). These sediments were deposited after the major 250-million-year extinction and contain fossils of mammal-like reptiles (Norman & Whitfield 2006). The sandstone and dolerite exposures support a higher diversity of succulents than the sandy areas in between.

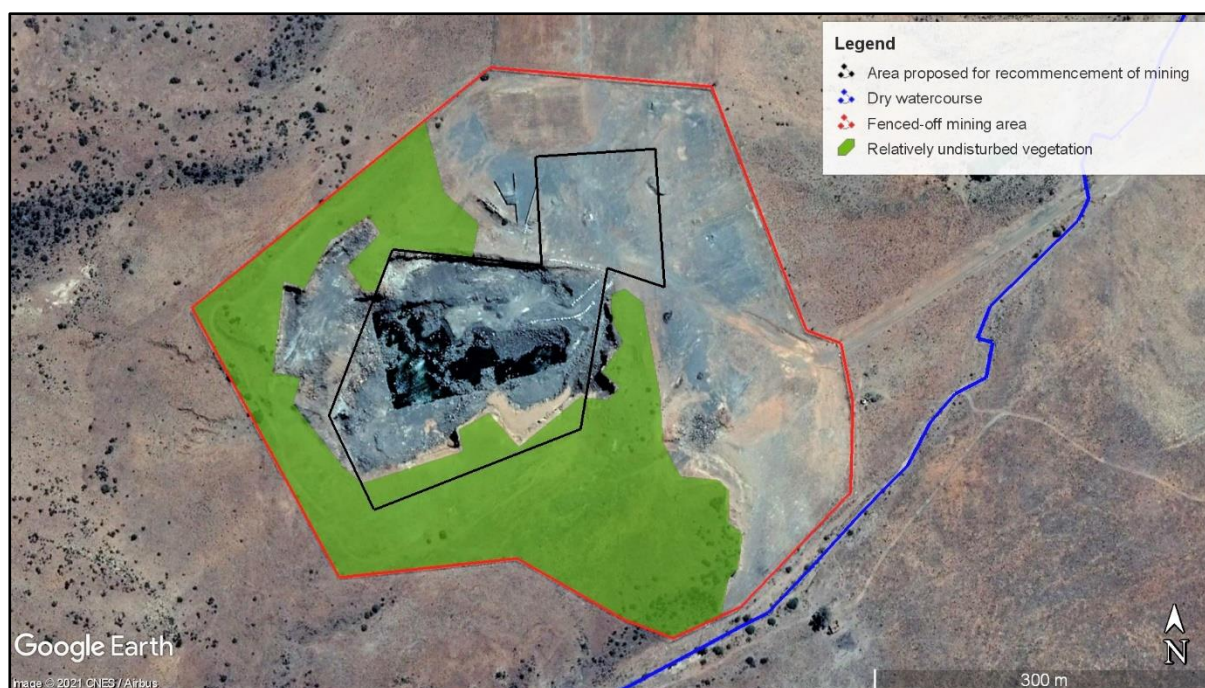
Map 5 Aerial photograph showing the biodiversity attributes of the mining site.

The natural vegetation found on site and the surrounding area is described as Eastern Upper Karoo. It comprises a prominent grass layer (<1 m tall), with a few emerging shrub/tree species (see Photos 3 & 4). Structurally it can be described as a low to short closed grassland, following Edward's (1983) classification. The area shown as good quality vegetation on Map 5 is in a fair to good condition, but a few farm/mine tracks and removed built structures were noted. The rest of the site (inside the fenced-off area) is clearly transformed or affected by past mining activities, but still supports a fair grass cover in places (see Photo 5). Diversity is obviously higher in the relatively undisturbed areas on the western and southern sides.

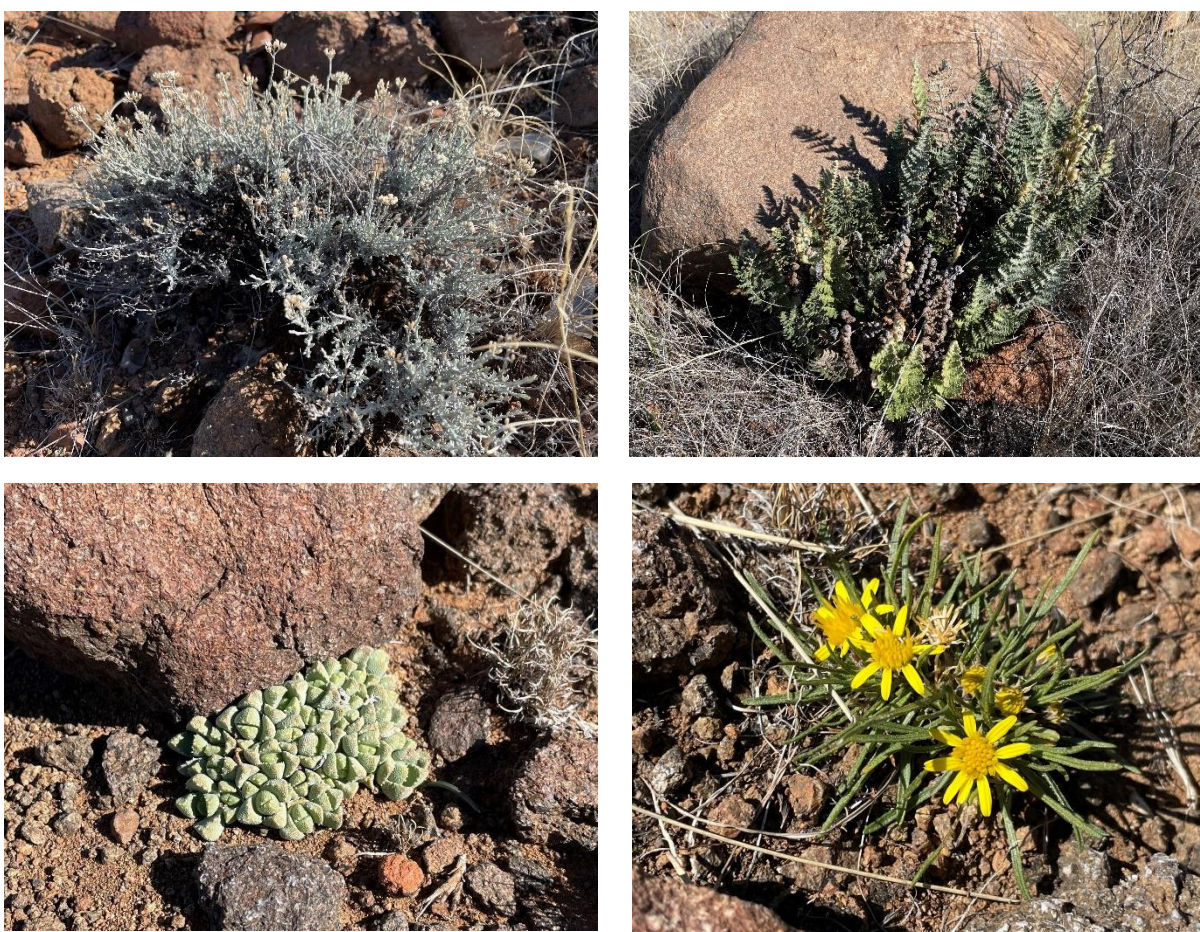
Photo 6 A few indigenous species recorded, with *Helichrysum zeyheri* (top left), *Cheilanthes eckloniana* (top right), *Stomatium duthiae* (bottom left) and *Geigeria filifolia* (bottom right).

Aizoon namaense (= *Galenia procumbens*), *Jamesbrittenia tysonii* and *Nemesia fruticans*. The small rock fern *Cheilanthes eckloniana* was also noted on exposed dolerite on the western side of the quarry. The more interesting flora was recorded outside the fenced-off mining area, notably on or adjacent to dolerite and sandstone exposures. Species recorded here include *Ruschia cradockensis* ssp *cradockensis*, *Trichodiadema* sp, *Chasmatophyllum musculinum*, *Stomatium duthiae*, *Crassula corallina*, *Anacampseros albidiflora*, *Euclea undulata*, *Geigeria filifolia*, *Gomphocarpus fruticosus*, *Pentzia punctata* and *Crassothonna cf patula*. See Photo 6 for some of the flora encountered. *Stomatium duthiae* and *Melolobium calycinum* are regional endemics. *S. duthiae* is typically associated with low-angled dolerite plates (see Map 6). No SCC were recorded.

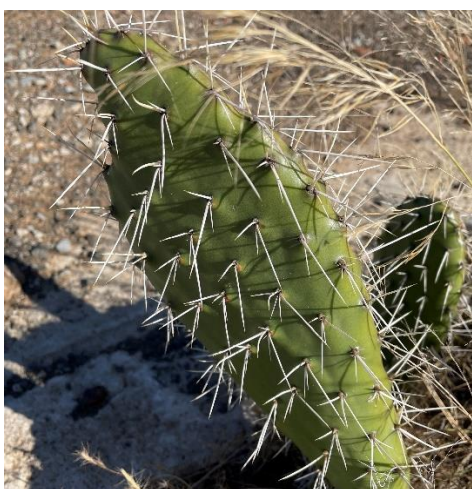
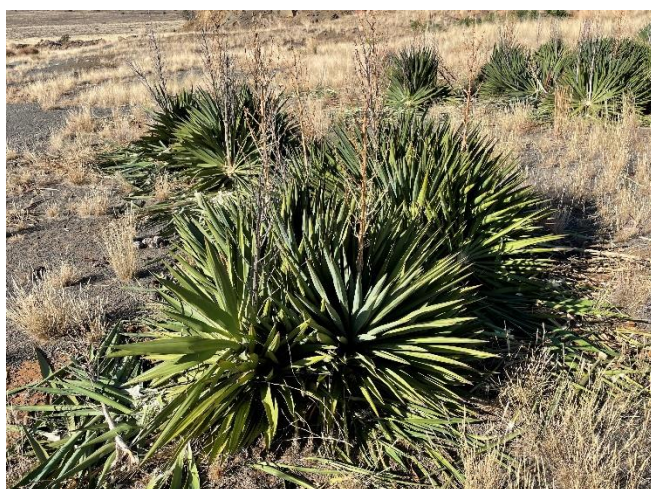
Photo 7 A few alien species recorded, with *Opuntia ficus-indica* (left) and *Yucca* sp (right).

Only three notable invasive species were recorded, namely *Opuntia ficus-indica*, *Datura stramonium* and *Salsola kali* (see Photo 7). All of them are listed as Category 1b invaders in terms of the National Environmental Management: Biodiversity Act (Act 10 of 2004) Alien and Invasive Species List (2016). *Datura stramonium* and *Salsola kali* are serious agricultural

pests, with the latter an aggressive invader, being able to rapidly take over new areas (Bromilow 2010). Its “only benefit is that it can act as an anti-erosion agent in bare areas” (Bromilow 2010). A small patch of *Yucca* sp was also recorded on site.

- Strict control must be exercised to avoid the harming/catching of wildlife.
- As an operational phase impact, alien control is required as an ongoing management concern. The spread of aliens into the adjacent area must also be prevented. Weeds, such as *Datura stramonium* and *Salsola kali*, can be easily controlled by hand-pulling or by using herbicides. Certain species, such as *Opuntia ficus-indica*, requires the removal and destruction of the entire plant.

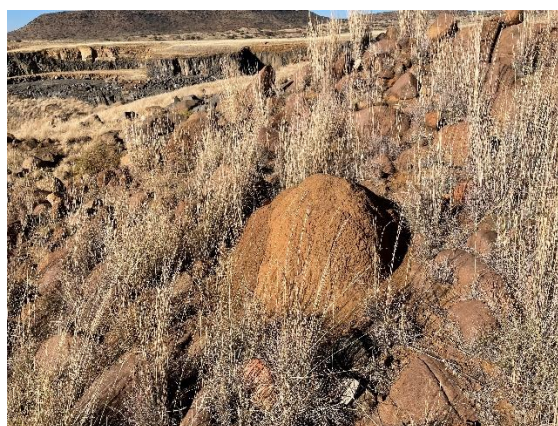
Photo 8 Porcupine scat (left) and a harvester termite mound (right).

- Aardvark (*Orycteropus afer*), widespread with a wide habitat tolerance. Aardvark burrows noted on site by the author.
- Springhaas (*Pedetes capensis*), widespread in grassveld areas.
- Rock hyrax (*Procavia capensis*), widespread in rocky habitats, observed by the author inside the quarry.
- Porcupine (*Hystrix africaeaustralis*), widespread, scat noted on site by the author (see Photo 8).

Significant termite activity (harvester termite mounds) was also noted (see Photo 8 above). No threatened terrestrial fauna species are known from the area. The Screening Report,
