Report on Geohydrological Impact Assessment For the Maritzburg Quarry near Pietermaritzburg, KwaZulu-Natal Province

Report Ref: 2021012

August 2021

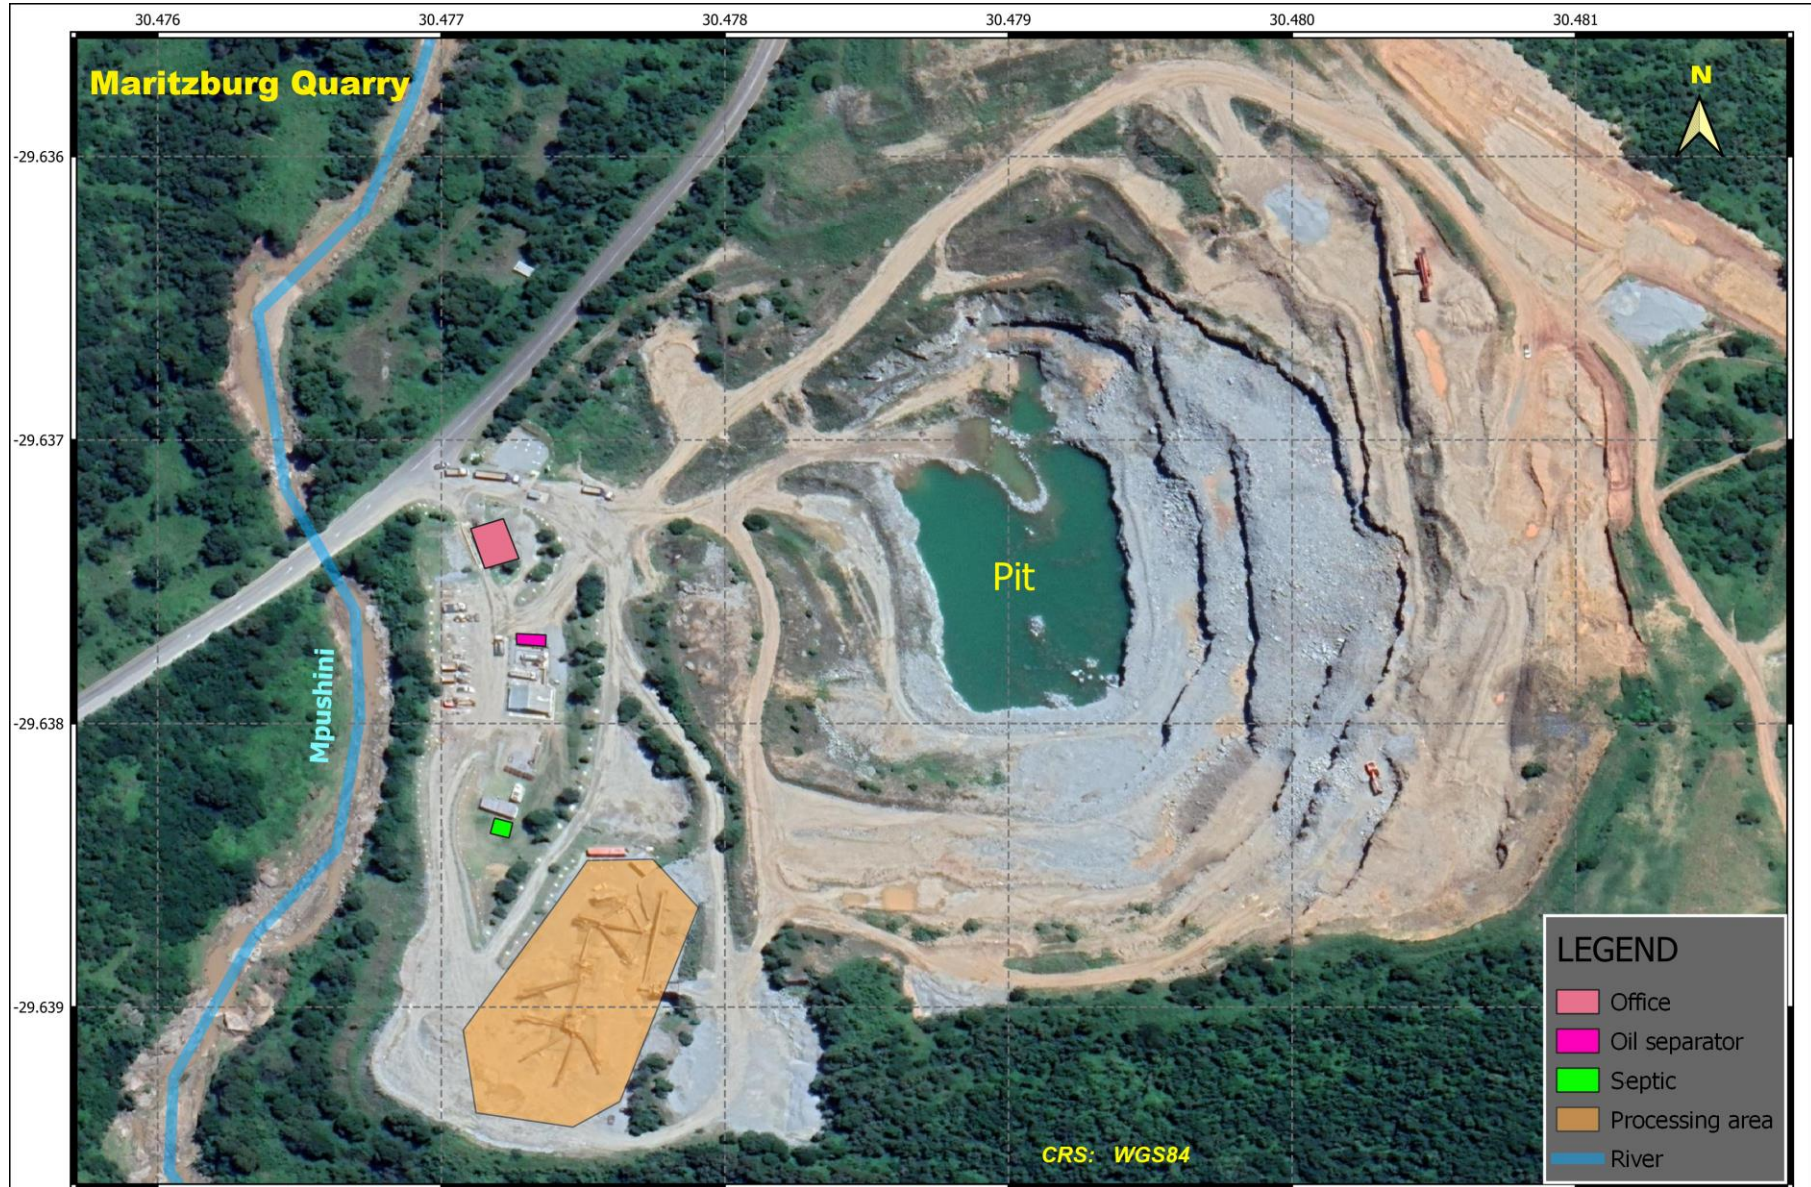
Figure 9.1 Site layout

- Drilling and blasting to extract the desired rock. It is reported that excavation will not go below the current level, which is at an elevation of 541 metres above mean sea level.
- Loading and hauling the material out of the excavation to the crushing and screening plant,
- Crushing and screening the recovered material at the crusher plant in order to reduce it to various size aggregate,
- Stockpiling the aggregate at a stockpile area until it is collected by clients.
