BIODIVERSITY ASSESSMENT: MARITZBURG QUARRY, PIETERMARITZBURG

February 2021

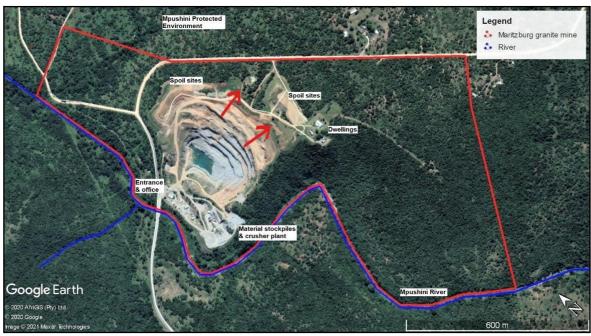
Map 2 Satelite photo illustrating mining activities on the site. The red arrows indicate the direction of future mining towards the north-eastern boundary of mining rights area.

Afrimat Aggregates (KZN) Pty Ltd is proposing to update the EMP for Maritzburg Quarry, which is situated in the Pietermaritzburg magisterial district. Stone aggregate (from dolerite) in being mined, which is used in the building/construction industry. The direction of mining is shown to be in an eastern direction towards the north-eastern boundary of the site as shown on Map 2.

It was pointed out to the biodiversity specialist that the direction of mining is towards the north- eastern boundary of the site (see Map 2). This is the boundary shared with the Mpushini Protected Environment. It is strongly recommended that, in order to safeguard the integrity of the protected area, an undisturbed buffer of a suitable width (e.g. 30-50 m) be determined and maintained between the latter and mining activities. This will allow the

- With regards to the future extension of the mining area towards the north-eastern boundary, which is shared with the Mpushini Protected Environment, it is strongly recommended that an undisturbed buffer of a suitable width (e.g. 30-50 m) be determined and maintained between the latter and mining activities. This will allow the movement of fauna around the edges of the mine and prevent the undermining of conservation efforts next door.

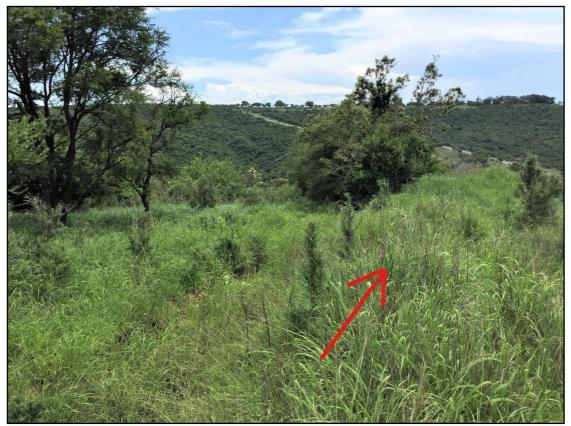
minor drainage lines crossing the northern and southern tips of the site. Associated with the river is a NFEPA wetland, fringing the river channel (see Map 3). The latter is covered by *Typha capensis*, *Phragmites australis* and other tall grasses and herbaceous species. The National Freshwater Ecosystem Priority Areas (NFEPA) project provides strategic spatial priorities for conserving South Africa's freshwater ecosystems and supports sustainable use of water resources. These priority areas are commonly referred to as NFEPA's. A stormwater cut-off trench was also noted behind the mine on southern side, which was created to divert runoff away from the excavation area (see Photo 3).

Photo 3 Overgrown stormwater cut-off trench on southern side of mine. The red arrow indicates the direction of flow.

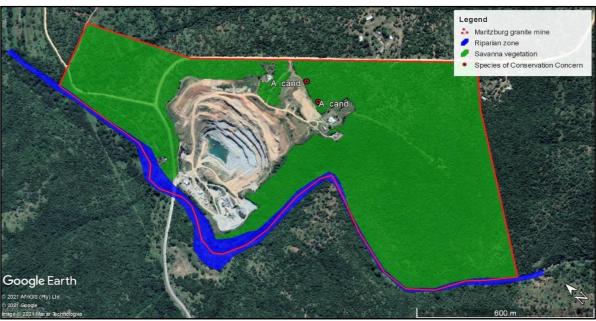
Map 6 Aerial photograph showing the biodiversity attributes of the study site.

The areas covered with savanna vegetation as shown on Map 6 seem to be in a fair to good condition with little disturbance. Botha (2005), however, noted that the mining site and surrounding areas have been disturbed by past agricultural activities. The scenery around the mining site was lush and green during the site visit. However, the dry winter situation may paint a different picture. As expected, some disturbances were noted on the edges of the mining area, such as localised erosion events, vehicular activities, spoiling of overburden and alien infestation (see Photo 6). Of a total of 49 species recorded, 15 (31%) were alien.

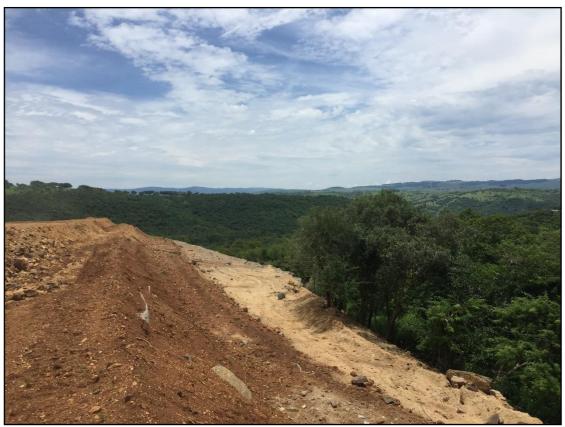
Photo 6 New overburden spoil site (terraced) on north-eastern side of mine.

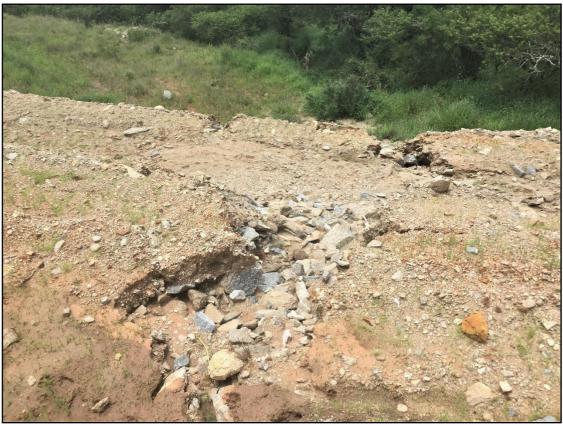
Mining activities seem to be well contained and not spread-out throughout the mining rights area. The surrounding natural vegetation also seem to be in a good condition. Encroachment into the vegetation was noted around the stockpile areas, notable on the northern side of the overburden stockpiles and on the southern side of the material stockpile area above the Mpushini River. Further encroachment of stockpiling into the natural areas should be kept in check unless it is allowed for in terms of the mining plan. Associated with stockpiling is localised erosion and the washing of silt into the green areas (see Photo 12). This needs to be addressed by means of stabilisation of the stockpile slopes.

Photo 12 Localised erosion at one of the overburden stockpiles.

- As a matter of priority, the stockpile slopes must be stabilised to prevent erosion and the washing of silt into the green areas and the Mpushini River. This can be achieved by means of a variety of ways, such a log stabilisation, geo-netting, hydroseeding, etc.
