Geohydrological Assessment for Cape Lime -Vredendal Dolomite and Limestone Operations.

GEOSS Report No: 2019/09-04

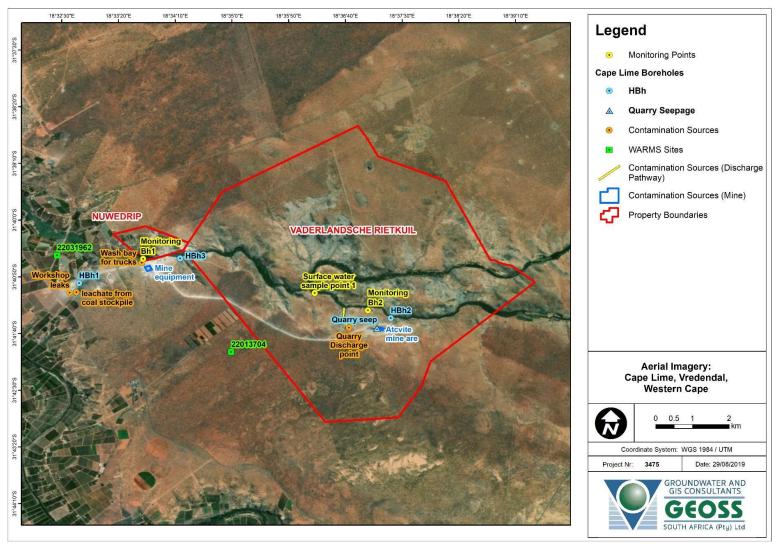
The industrial nature of the site and presence of several contaminant sources means that groundwater and surface water contamination may occur.

Map 7: Potential contamination sources on site and proposed monitoring points

The risk can be mitigated by implementing monitoring of water quality along the down gradient boundary of the property and at points where groundwater discharge enters rivers.
